**National Highway  
Traffic Safety  
Administration**

**DYNAMIC SCIENCE, INC.**  
In-Depth Accident Investigation

Contract DTNH22-94-D-27058  
Case DSI-94-AB-022

## TECHNICAL SUMMARY

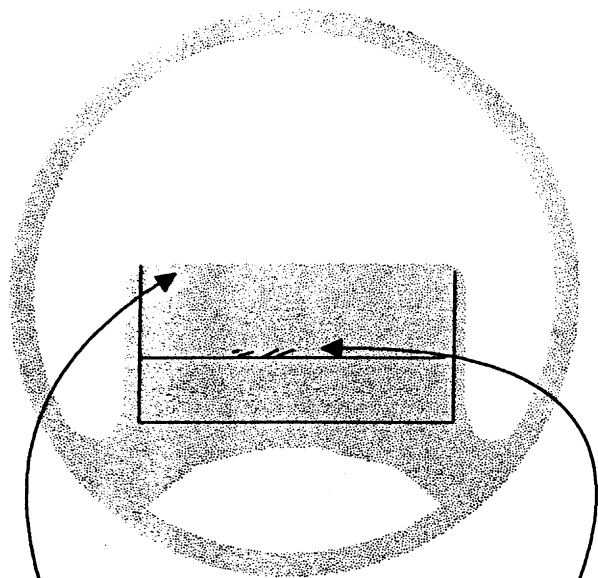
upper torso, with the resulting back pressure cracking both the inner (hard plastic) and outer (soft plastic) covers. There is evidence (a clothing transfer) that indicates the driver came into contact with the exterior of the module cover. The concussive force of the deployment was primarily to the left side of the driver's upper body causing a laceration of the heart and the ascending aorta.

**module cover torn away**

**Cloth transfers**

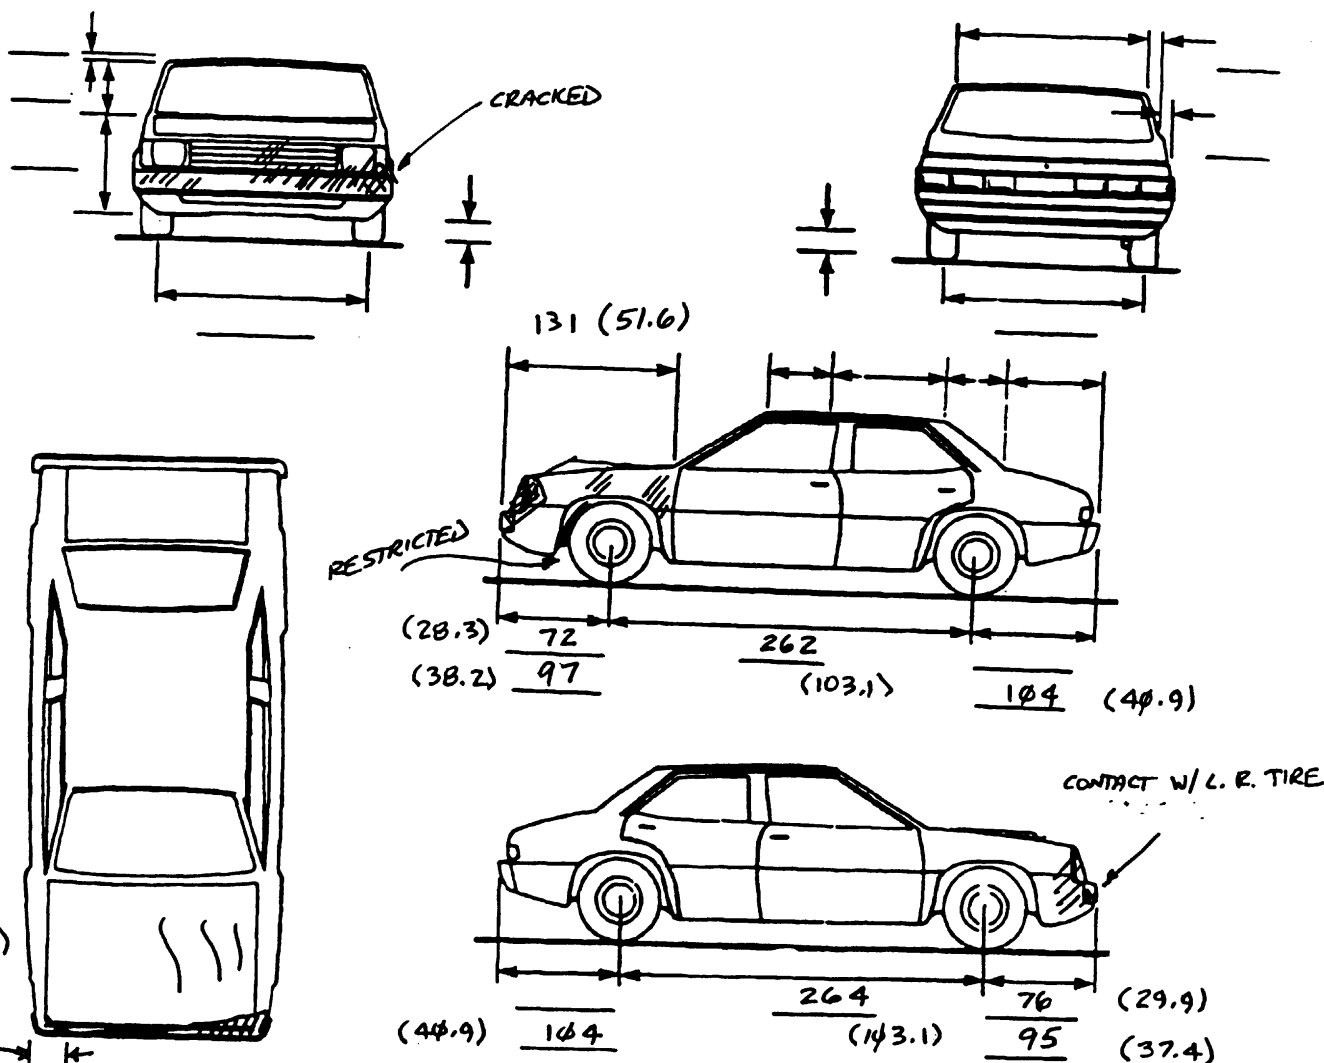
## VEHICLE DAMAGE SKETCH

Specific Impact Number	Plane of Impact C-Measurements	Direct Damage		Field L	C <sub>1</sub>	C <sub>2</sub>	C <sub>3</sub>	C <sub>4</sub>	C <sub>5</sub>	C <sub>6</sub>	± D
		Width (CDC)	Max Crush								
1	BUMPER	52.7	9.6	51.5	9.6	5.1	3.1	2.4	2.75	5.3	
	- FREE SPACE		-4.φ		-4.φ	-1.75	-1.2	-1.2	-1.75	-4.φ	
			5.6		5.6	3.35	2.9	2.2	1.φ	1.3	φ
1	BUMPER	134	14	131	14	9	7	φ	3	3	φ

NOTES: Sketch new perimeter and cross hatch direct damage and single hatch induced damage on all views. Annotate observations which might be useful in reconstructing the accident (e.g., grass in tire bead, direction of striations, scuff on sidewalls, etc.). If pulling trailer, sketch type of trailer and damage received on the back of this page.  
Annotate any damage caused by extrication such as component removal by torching, prying, or hydraulic shears.

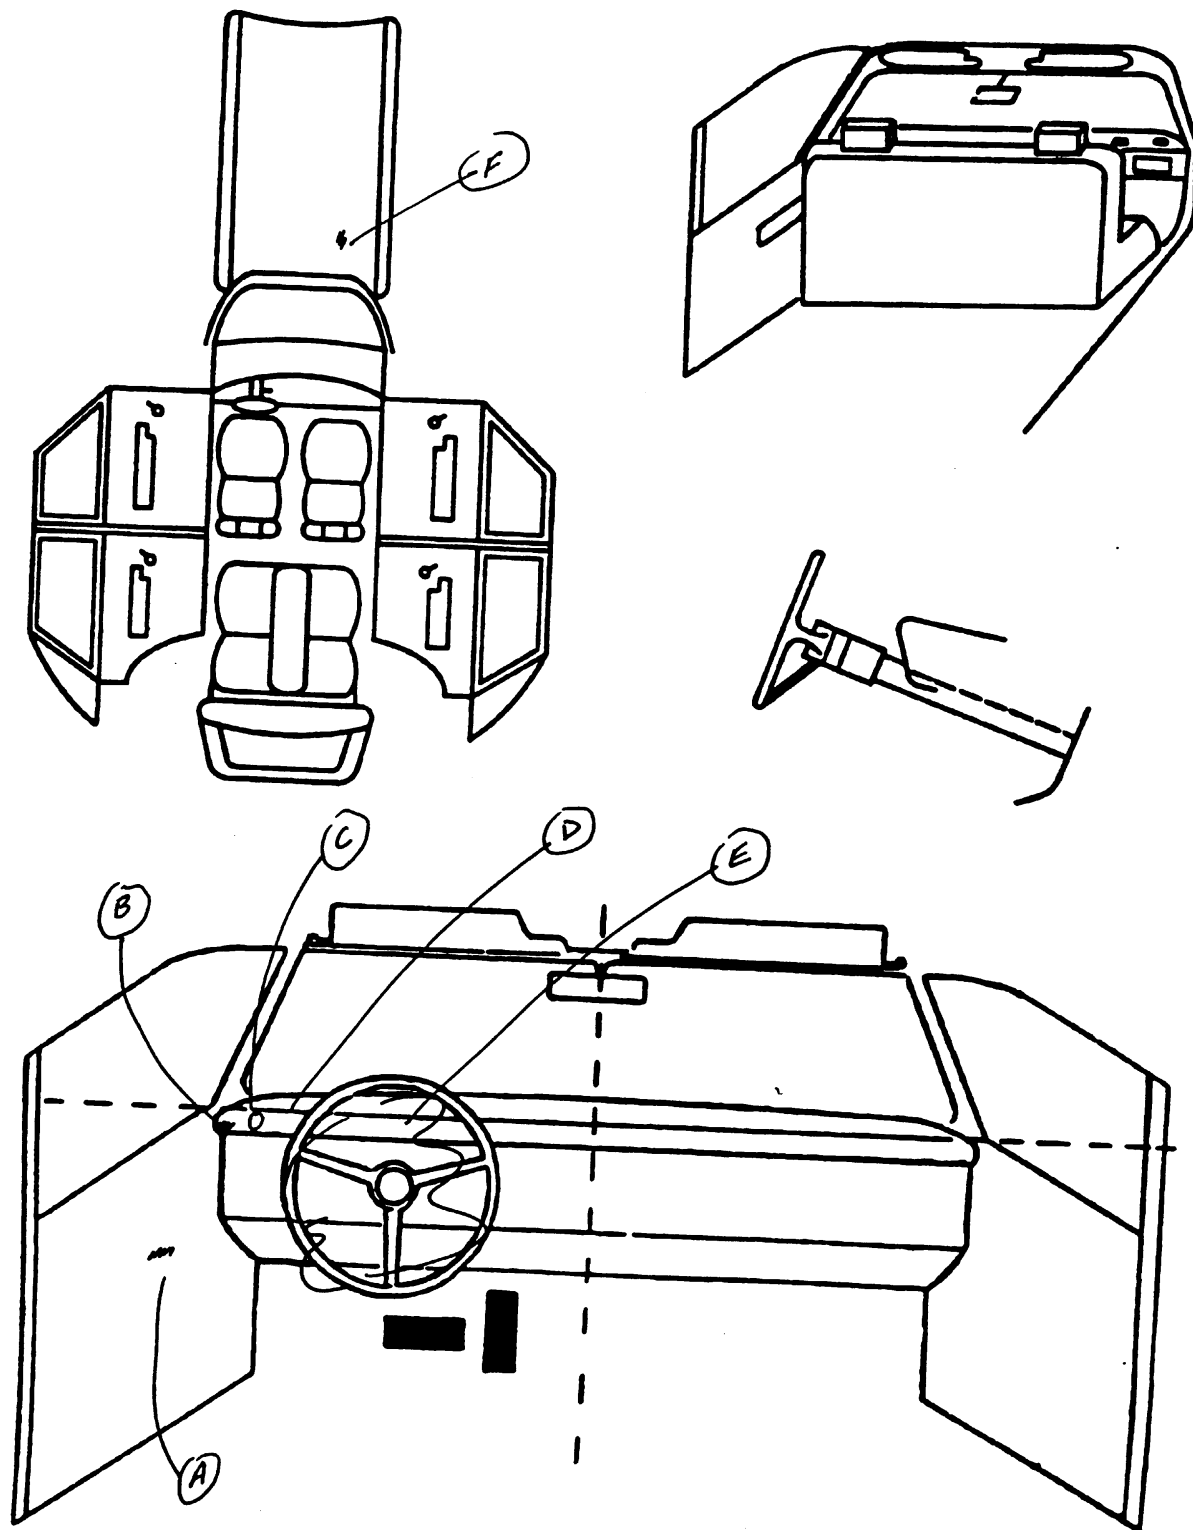
# VEHICLE INTERIOR SKETCHES

Sketch windshield contact(s) and the damaged area(s) on the instrument panel outline (e.g., radio, glove compartment, damage to instrument panel structure).  
 Cross hatch contact points, draw spider webs or use other annotation as may be appropriate.  
 Annotate the contacted area with a letter (begin with A) and list on the Points of Occupant Contact page.

Contact	Interior Component Contacted	Occupant No. If Known	Body Region If Known	Supporting Physical Evidence	Confidence Level of Contact Point
A	21	01	-	SCUFF	3
B	09	01	L. HAND?	SCUFF	3
C	09	01	L. HAND?	SWITCH OFF	3
D	09	01	-	SPEEDOMETER CRACKED/ENTIRE PANEL SHIFTED	2
E	45	01	FACE	LIPSTICK	1
F	54	01?	-	SMALL SCUFF	3
G					
H					
I					
J					
K					
L					
M					
N

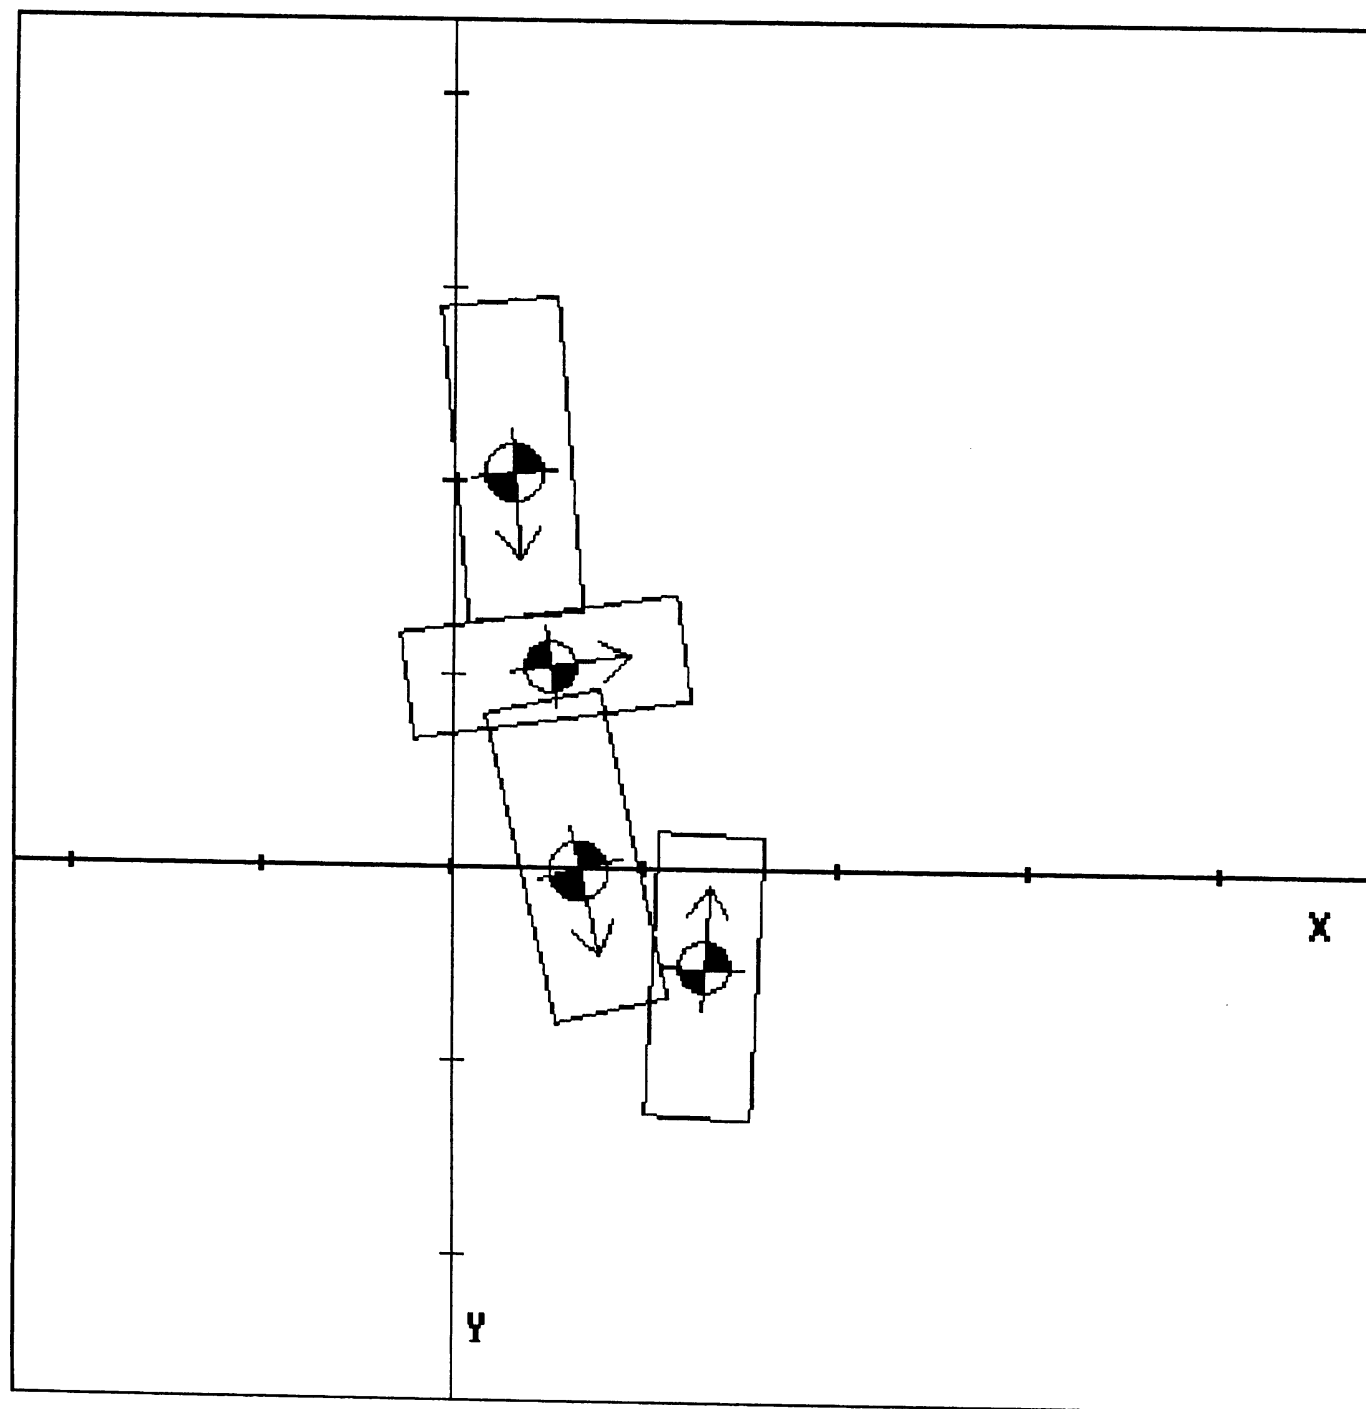
# **EDCRASH** Site Drawing

Ueh #1	Ueh #2
<b>Impact</b>		
Speed	21.8	5.2
X	3.0	5.0
Y	-20.5	-10.5
Psi	85.0	-8.0
<b>Rest</b>		
X	6.5	13.0
Y	0.0	5.0
Psi	77.0	-87.0

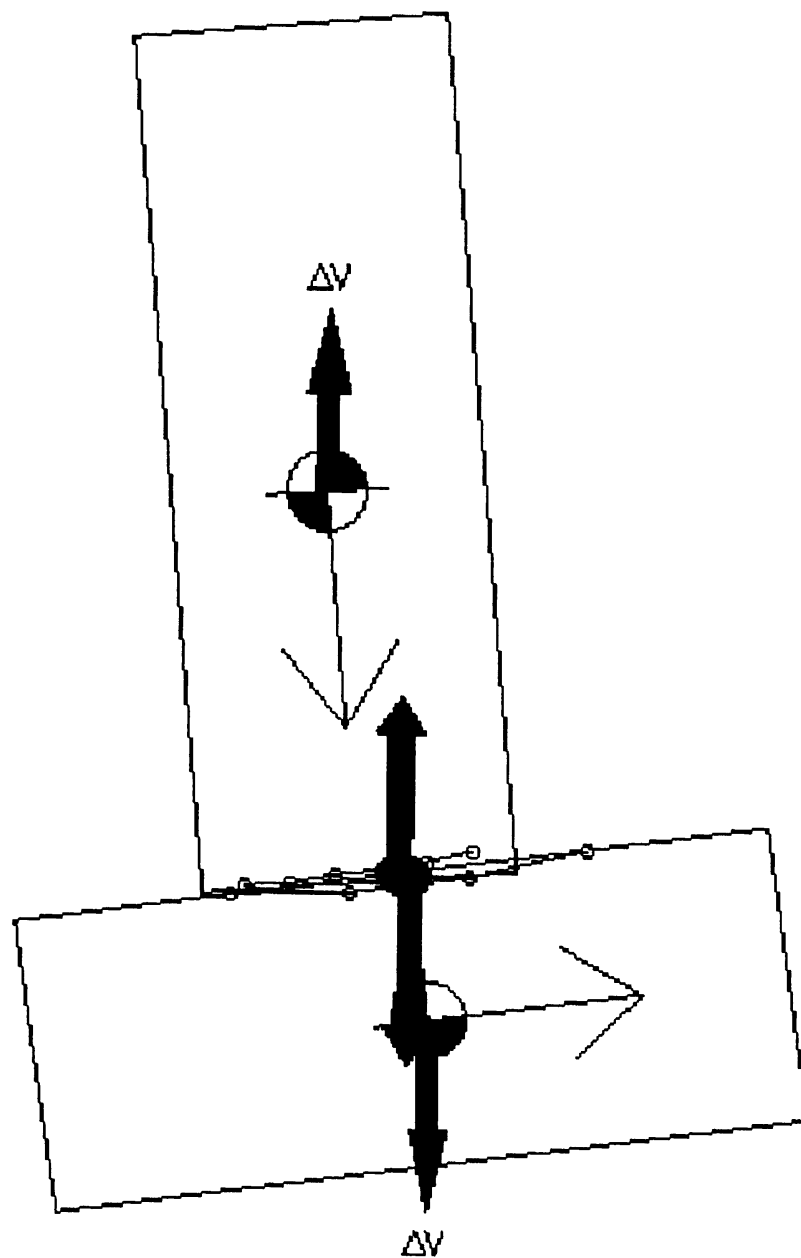
**EDCRASH**  
At Impact

Ueh #1	Ueh #2
Velocities (mph)		
Tot	21.8	5.2
Fwd	21.8	5.2
Lat	0.0	0.0
Beta	0.0	0.0

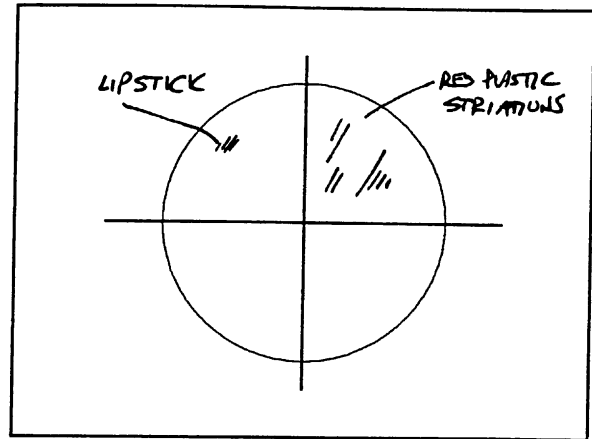
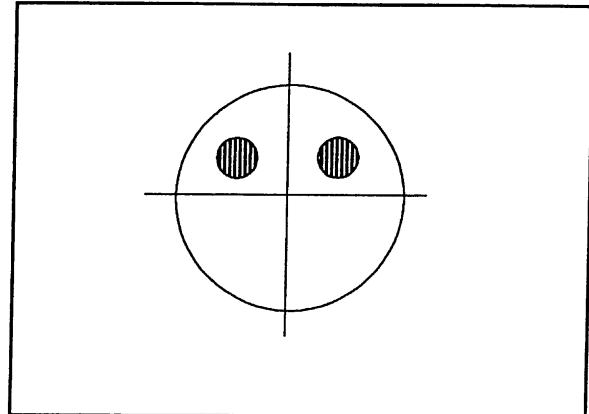
**DESCRIBE SYSTEM AND BAG DAMAGE:**

**NOTE DAMAGE AND CONTACT MARKS ON AIRBAG DIAGRAMS BELOW:**
